# UNDERWATER BRIDGE INSPECTION REPORT

STRUCTURE NO. 30508

RUM RIVER

MINNESOTA DEPARTMENT OF TRANSPORTATION  
UNDERWATER BRIDGE INSPECTION

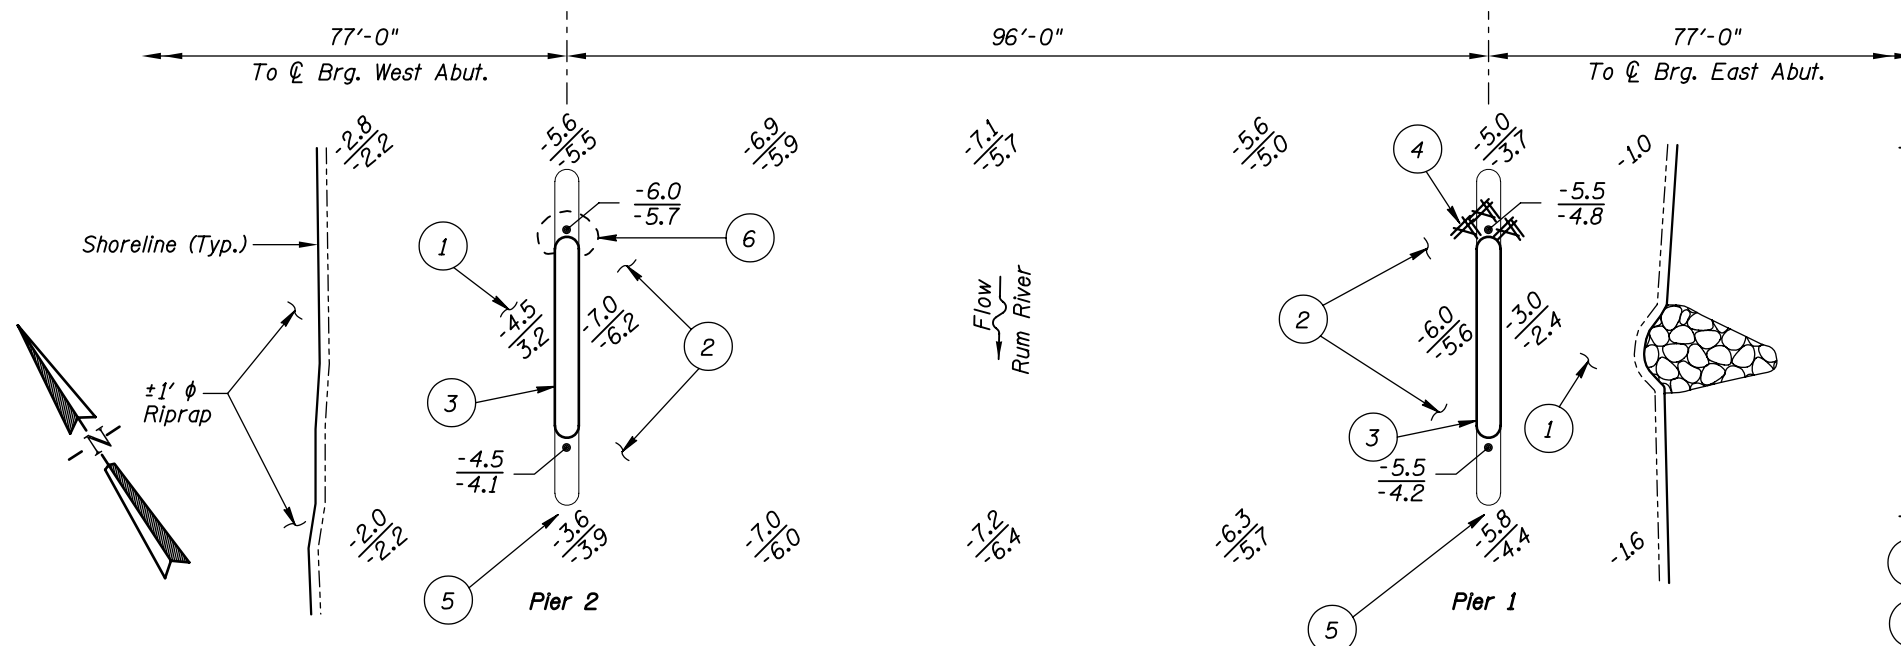
SOUNDING PLAN

- 1 The channel bottom consisted of 8- to 12-inch-diameter riprap.
- 2 The channel bottom consisted of firm sandy gravel with probe rod penetrations of 2 to 3 inches.
- 3 The concrete surface was in very good and sound condition with light scaling.
- 4 A minor accumulation of 2- to 3-inch-diameter timber debris was observed at the upstream nose.
- 5 The channel bottom consisted of sandy infilling with probe rod penetrations of 6 inches.
- 6 Minor scour depression around upstream nose with 3 foot radius and 1 foot depth.

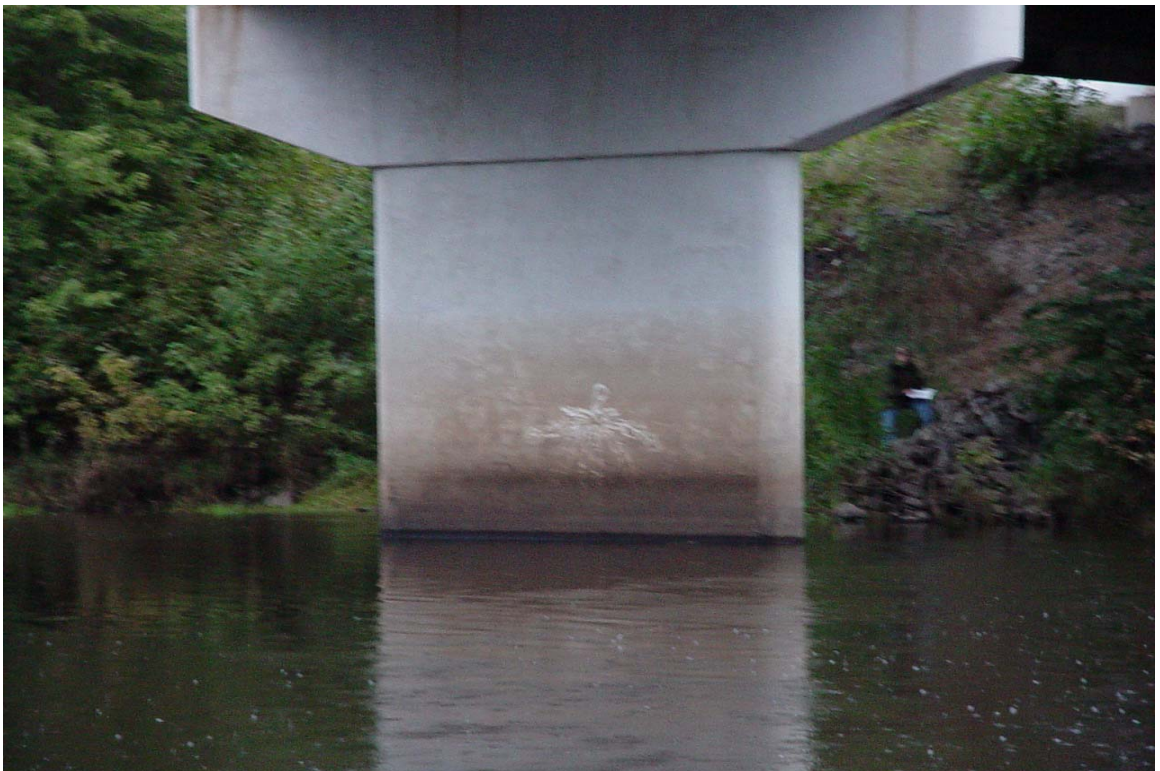
- (A) The concrete surfaces below water were in very good and sound condition; however, they were slightly rough due to light scaling at the waterline.
- (B) A minor accumulation of 2- to 4-inch-diameter timber debris was observed on the channel bottom at the upstream nose of Pier 1.
- (C) A 3-foot-radius, 1-foot-deep scour depression was observed at the upstream nose of Pier 2.

Photograph 2. View of Pier 1, Looking East.

- (A) Reinspect all substructure units underwater within the normal maximum (NBIS) interval of five (5) years.

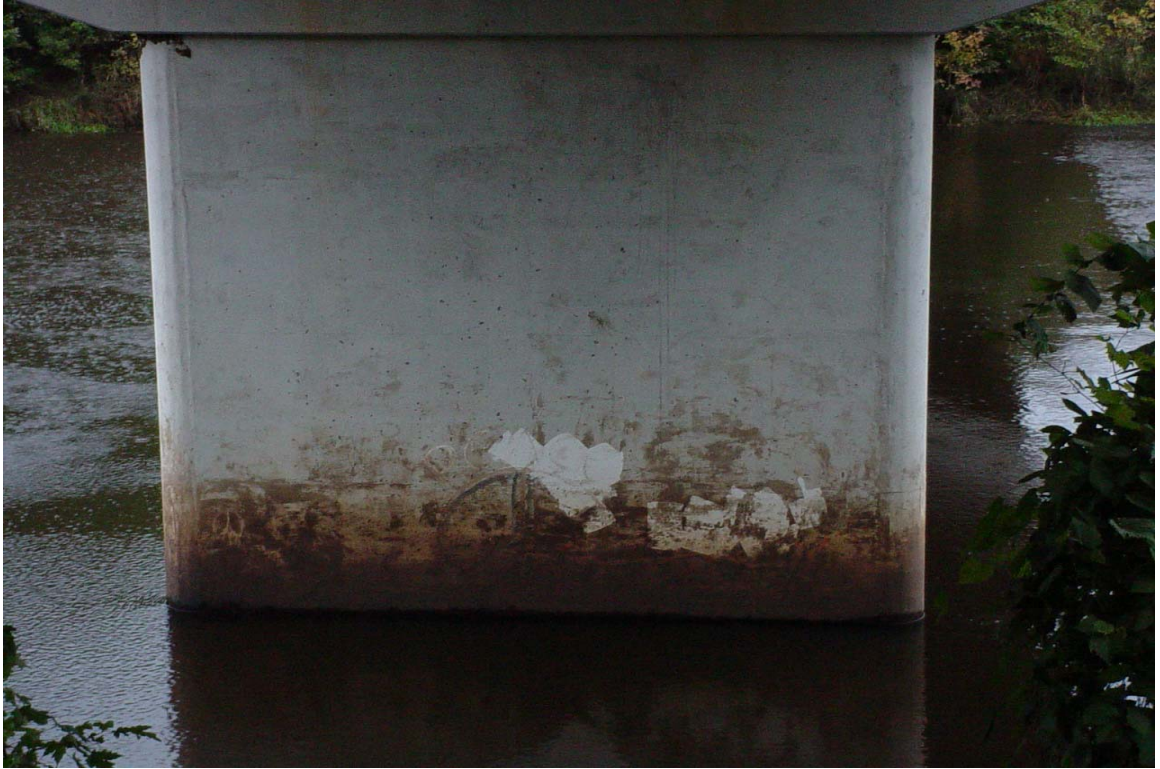
Photograph 3. View of Pier 2, Looking East.
